Efficacy of Radiological Decontamination

TECHNICAL MEMORANDUM
DREO TM 2001-060
August 2001

D.S. Haslip, T. Cousins and B.E. Hoffarth
Radiation Effects Group
Space Systems and Technology Section

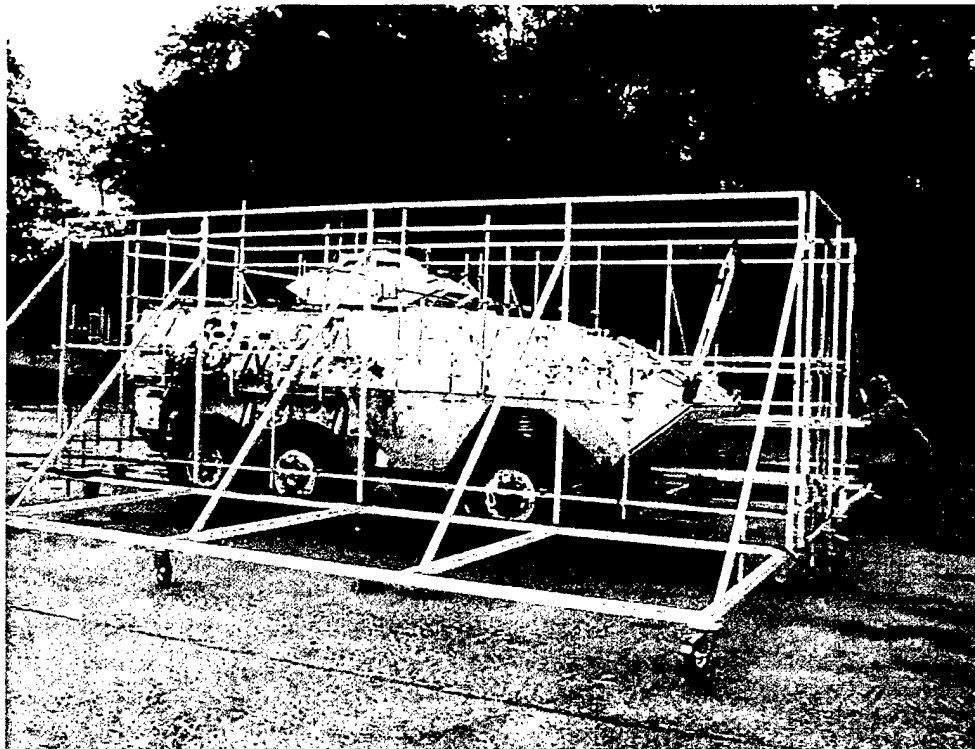
Figure 1. Measuring contamination levels with the ETBS cage. Seventy-seven Geiger tubes are suspended by the metal structure. The cage rides on wheels, allowing it to be rolled into place, enclosing the vehicle.

Once the radioactive sand has settled out of the air, the vehicle is moved out of the contamination area to an outdoor concrete pad where its exterior contamination distribution is assessed. This is done by ETBS with 77 Geiger tubes mounted on a specially designed steel "cage" (see Figure 1). The cage envelops the vehicle and allows each Geiger tube to be positioned reproducibly at the same location on the vehicle each time the measurement is made. Each Geiger tube is placed about 5 cm from the surface of the vehicle. Since Geiger tubes measure dose rates, and since the contamination pattern on the outside of the vehicle is not uniform, it is difficult to infer contamination levels from this measurement. However, a rudimentary assessment can be made, and the measurements are very useful for identifying the differences in contamination levels over the surface of the vehicle. The Geiger tube measurements are performed prior to decontamination and after each stage of decontamination to monitor progress.

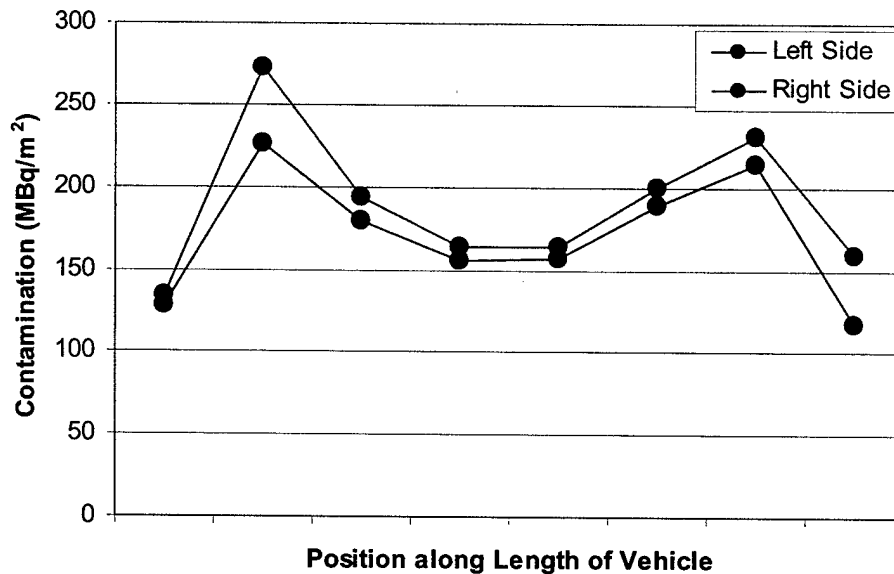
Figure 2. Contamination levels measured on the witness plates next to the Grizzly in the contamination area.

As noted above, the first measurement of the vehicle contamination is performed in the fallout room. One row of witness plates is placed on each side of the vehicle prior to contamination and is collected following contamination and measured. Figure 2 shows these measured contamination levels as a function of distance along the length of the vehicle. The series labeled "left side" denotes the side on which the driver sits. Points corresponding to the front of the vehicle lie on the left side of the graph. The contamination level on the witness plates is $180 \pm 40 \text{ MBq/m}^2$. The figure shows that the right side appears to be slightly more contaminated than the left, and that the front-to-back variation is the dominant one, in the neighbourhood of 23% (evident from the uncertainty quoted above).

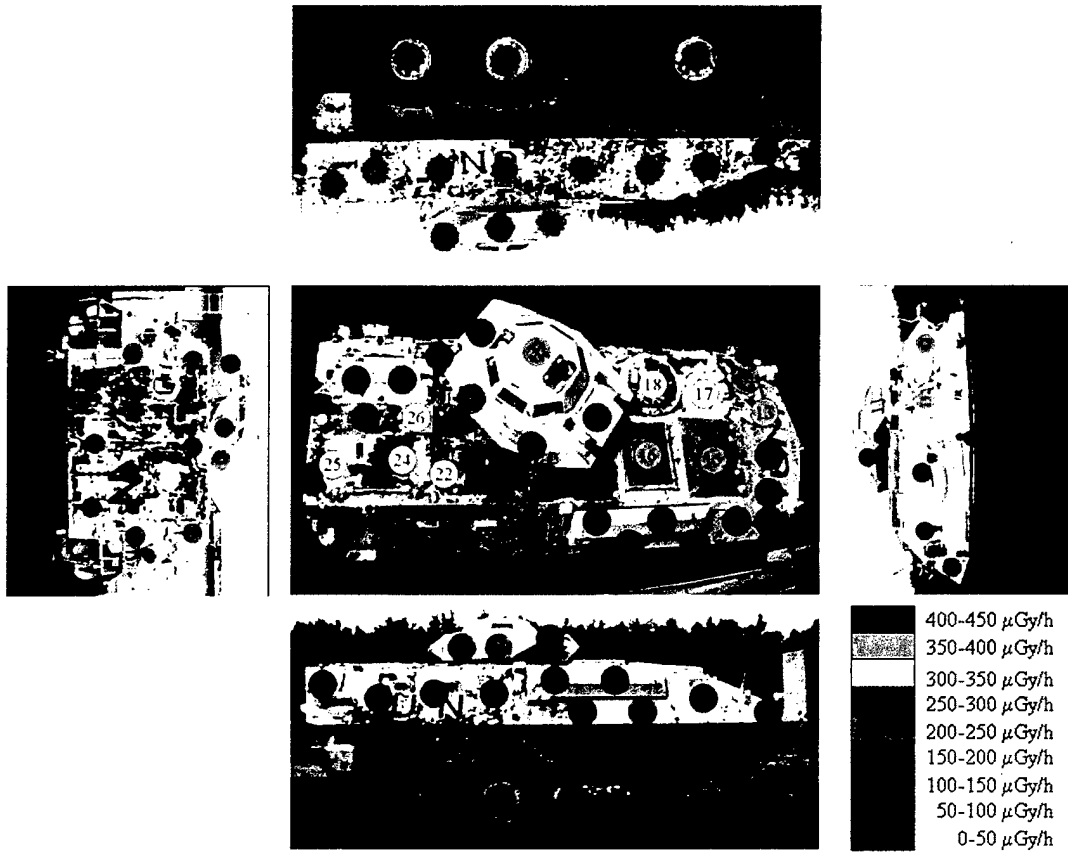
Figure 3. Contamination levels measured with the Geiger tube cage immediately after contamination.

The second measurement of the vehicle contamination takes place in the Geiger tube cage. Figure 3 is an "unfolded" picture of the Grizzly with the Geiger tube measurement points superimposed. The points are colour-coded according to the first measurement of the contamination. As expected, the contamination levels are highest on the horizontal top surfaces of the vehicle, where the sand was able to fall and remain. Contamination levels are lower on near-vertical surfaces, where it is harder for sand to settle and cling. Contamination levels are lowest on down-facing surfaces, to where contamination could not fall directly from above. Contamination on the right

side of the vehicle is slightly higher than on the left, in agreement with the witness plate measurements above. Previous measurements at DEP [1] have suggested that the conversion factor from dose rates measured with the cage to contamination levels should be approximately $1.65 (\mu\text{Gy/h})/(\text{MBq/m}^2)$. This would imply that contamination levels on the vehicle ranged from 4 to 260 MBq/m^2 ; the maximum of this range is in good agreement with the maximum contamination level measured on the witness plates. It is difficult to get a second comparison point because contamination levels on the witness plates vary only because of the irregularities in the contamination system itself, whereas contamination levels on the vehicle also depend on the stickiness of vehicle surfaces and their variation from horizontal.

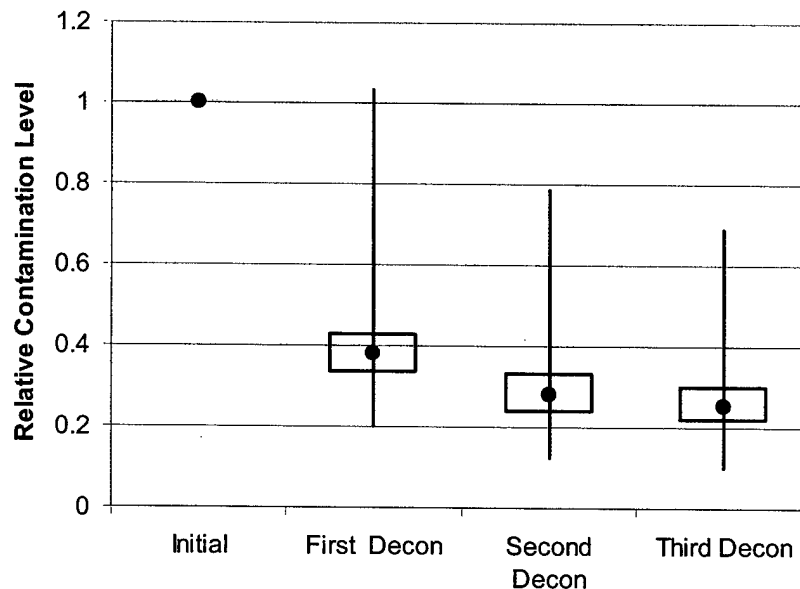
Figure 4. Box and whisker plot showing the relative contamination levels (according to measurements from the Geiger tube cage) on the vehicle after contamination and after each of the three phases of decontamination. In a box and whisker plot, the vertical line defines the maximum and minimum of the distribution, the box defines the upper and lower quartiles, and the circle denotes the median.

A large quantity of data was collected in these trials, especially with respect to external contamination measurements. Before decontamination and after each of three decontamination attempts, the external contamination levels were measured in the Geiger tube cage. While all of these data give a good picture of the state of the vehicle as a function of time, the interpretation of decontamination effectiveness at individual locations on the surface of the vehicle is neither feasible nor useful. Variations in the surface and in the adhesion of the contamination to the surface, not to mention the complexities in what happens to the contamination as it is washed away from a given location, contribute to a very complicated picture of decontamination efficacy when viewed location by location. Figure 4 shows this clearly in a box and whisker plot of the Geiger tube measurements. While the upper and lower quartiles of these data are not widely spread, it is clear that some data points lie far away from others. For example, after the first decontamination, one of the locations was actually more contaminated than it had been the first time (a result of ^{140}La transfer from a more contaminated area to a less contaminated one).

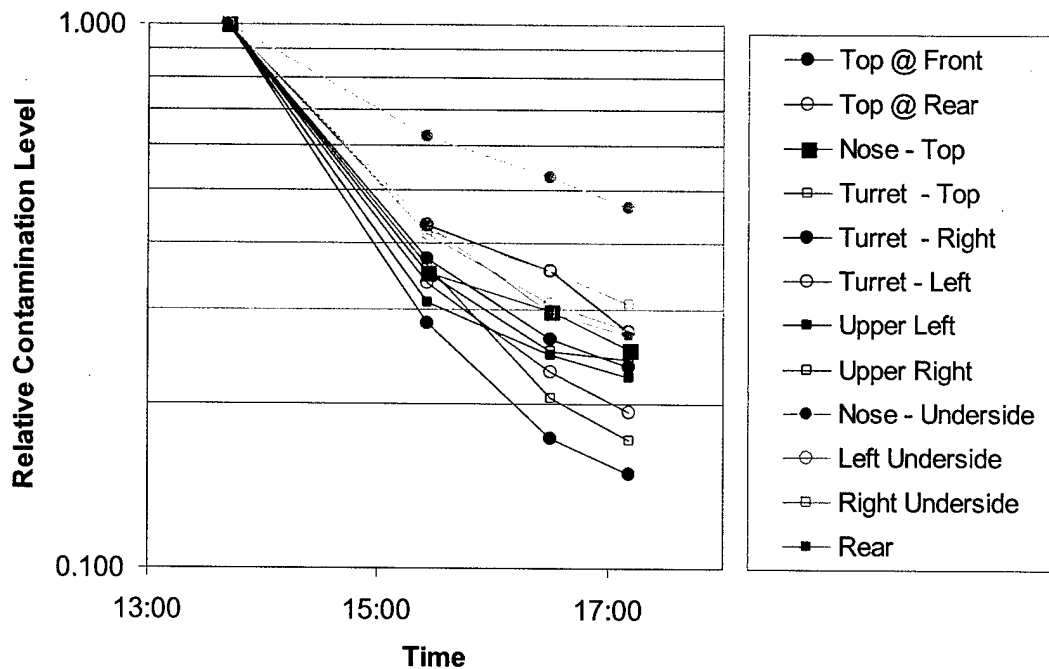
Figure 5. Relative contamination levels (according to Geiger tube readings) as a function of time. The 77 Geiger tube readings are grouped into 12 regions, shown in the legend. The four measurement times denote the measurement following contamination and each of the measurements following the three decontamination attempts.

The relative contamination levels (normalized to unity initially) are shown in Figure 5. This is much easier to look at than plots of 77 individual data sets and allows one to see patterns in the decontamination efficacies.

The first decontamination reduced the contamination level by 60% on average, with 73% removed by the final measurement. The semi-log plot in Figure 5 (in which regions with contamination levels falling by identical factors are represented by parallel lines) shows that the greatest difference in decontamination efficacy occurred during the first decontamination, with later attempts producing more or less similar results in all areas. The greatest outlier is the underside of the "hood" or "nose" of the vehicle. This region had very low decontamination efficacy, but this was also the area with the lowest initial contamination levels. The former result may be a consequence of the latter, in that none of the contamination initially present on this surface was loose, but all was adhered to the surface in some way making decontamination more difficult. On the other extreme, the top surfaces (in red in the plot) show the largest decontamination efficacies, an indication that some of the contamination that was initially present was loose, and thus quite easy to remove.

The behaviour of the 12 data series in Figure 5 suggest an additional grouping of the measurement points with the goal of further simplifying the data analysis. In this new scheme, the measurement points are put in the following three groups:

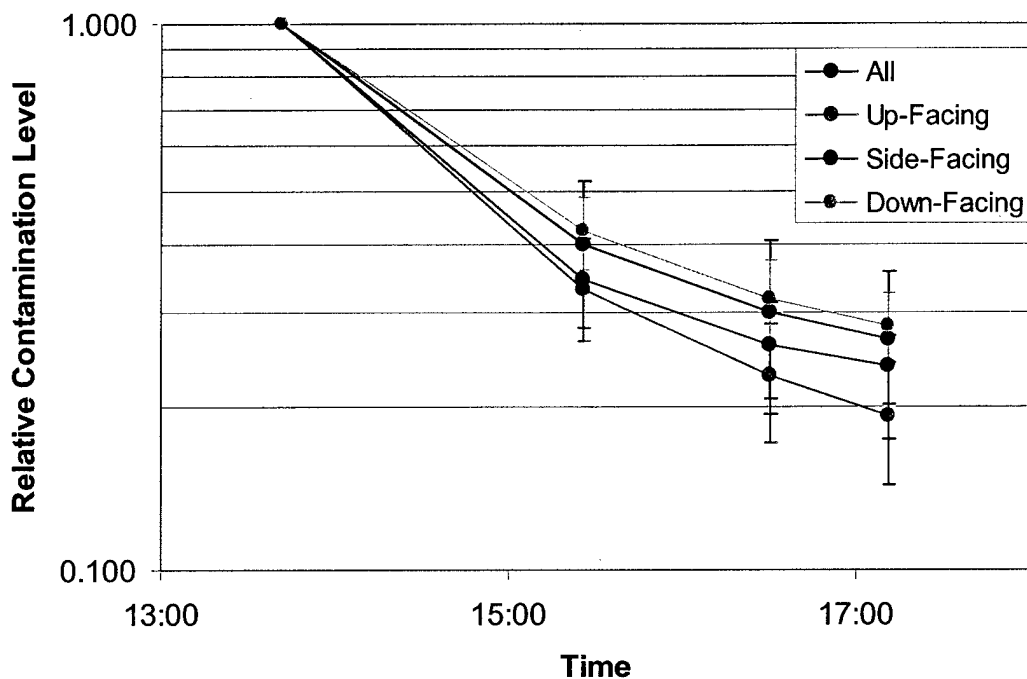
Figure 6. Relative contamination levels (according to Geiger tube readings) as a function of time. The 77 Geiger tube readings are grouped into 3 regions, shown in the legend. The overall averages are also shown. The error bars are standard deviations for the distributions.

Figure 6 shows the relative decontamination efficacies for these three groups, plus the overall averages. The error bars shown are the standard deviations of the groups. The trends of the data are identical to those discussed above. Namely, the "up-facing" surfaces show the largest decontamination, whereas the "down-facing" surfaces show the converse trend. Further, the differences between the data sets are largest following the first decontamination, and are more similar in the second and third attempts.

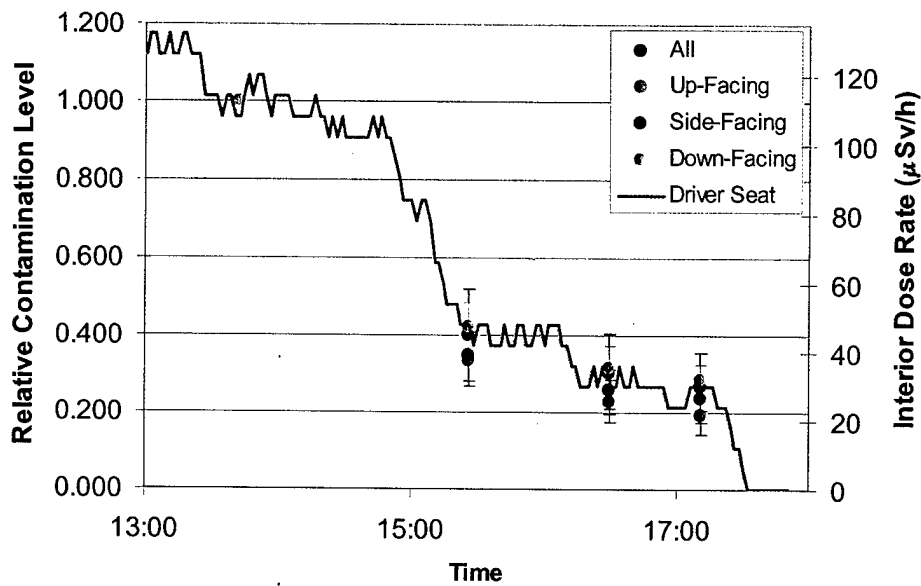
Figure 7. External and internal measurements of contamination. The data points are the contamination levels measured by the Geiger tube cage for each of the three surfaces defined in the previous section. The line is the dose rate measured by the dosimeter sitting on the driver's seat. The dosimeter dose rate falls to zero at 17:30 when the dosimeter is removed from the vehicle.

Figure 7, Figure 8, Figure 9, and Figure 10 show the dose rate measured by these dosimeters as a function of time. For comparison, the relative contamination levels measured by the Geiger tube cage (and shown in Figure 6) are also shown in these graphs. The scale of the secondary y-axis has been adjusted so that the interior dose rates and the relative contamination levels coincide at the first cage measurement.

The interior dose rate plots are characterised by a certain amount of jaggedness. This is caused by round-off error in the dosimeters (whose dose resolution is only 1 μSv). It is possible to remove this by smoothing, but the data have already been averaged over 10-minute periods, and further smoothing starts to impact an analysis of the time evolution of the contamination. All of the dosimeter plots also show a decrease to zero at around 17:30; this is due to the dosimeters being removed from the vehicle at the end of the experiment, not to a complete decontamination.

All four interior dose-rate histories are in excellent agreement with the exterior contamination measurements. This supports the trivial result that the dose rate inside the vehicle is proportional to the contamination outside. Actually, the result in this case is more important for the following reason. Despite attempts to make the Grizzly waterproof, a considerable quantity of liquid entered the vehicle during the decontamination process. This liquid was found to contain Lanthanum-140 and it was thought that this interior contamination of the vehicle might have spoiled attempts to measure protection factors. However, it appears based on these results that the contribution to interior dose rates from this liquid is small, probably because the concentration of Lanthanum-140 in this liquid is also small.

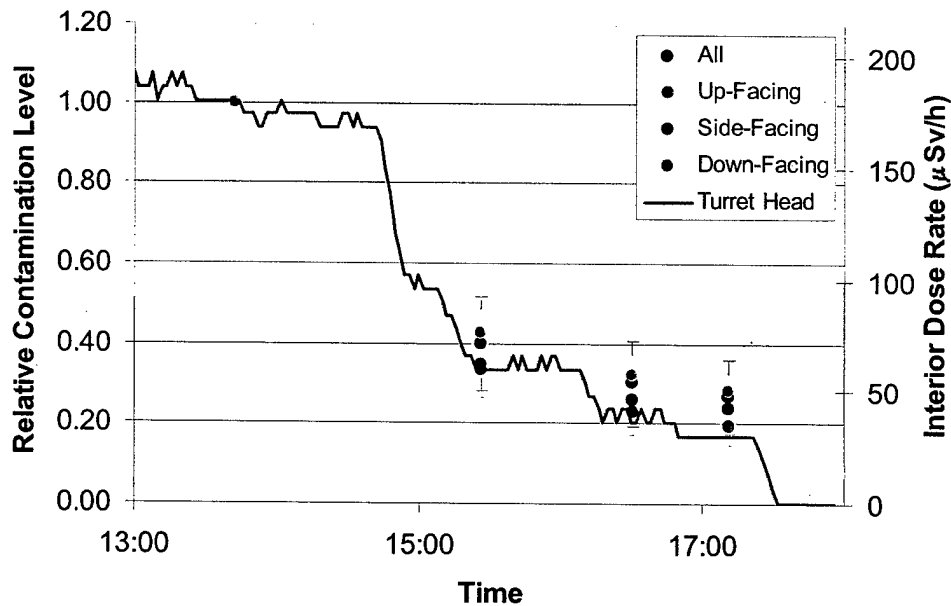
Figure 8. As in the previous figure, but now the line is for a dosimeter at the head position in the turret.

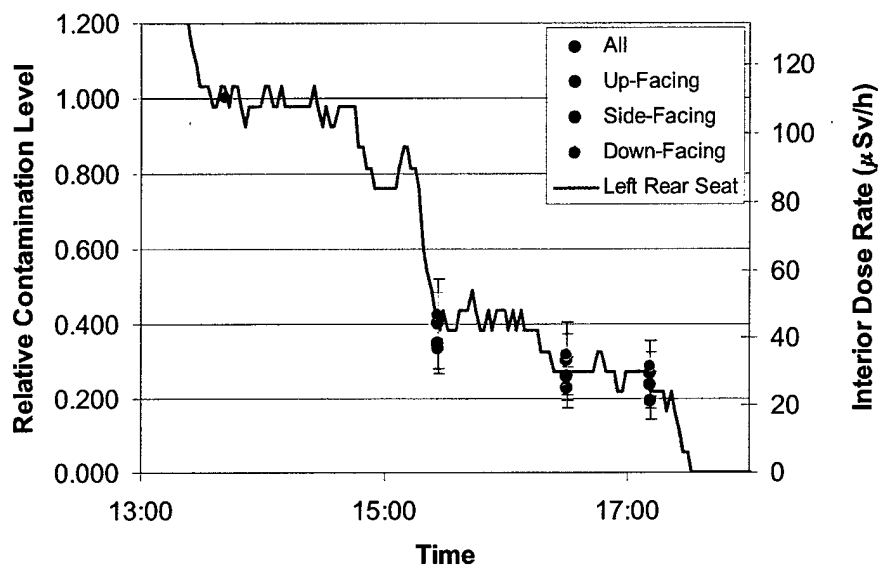
Figure 9. As in the previous figure, but now the line denotes the dose rate on the left passenger bench, near the rear of the vehicle.

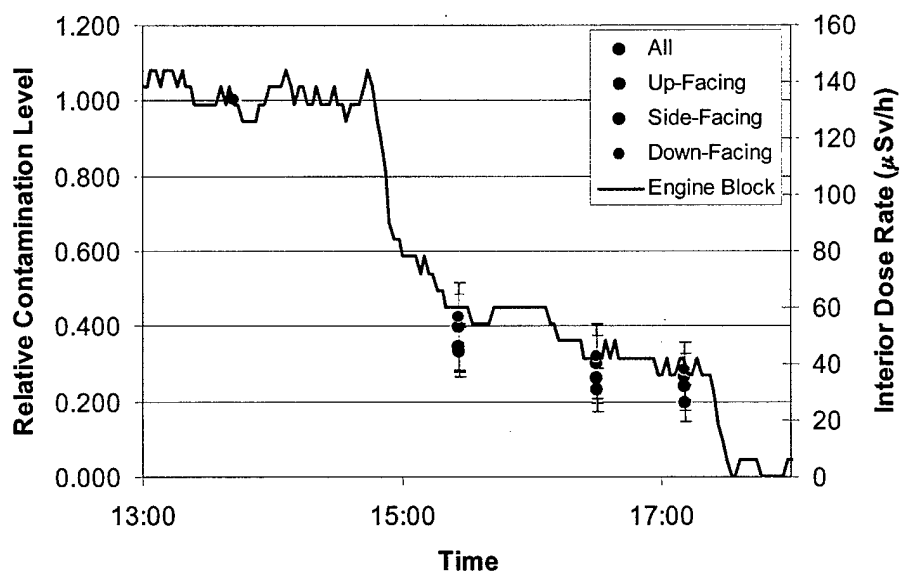
Figure 10. As in the previous figure, but now the line denotes the dose rate measured at waist height, immediately behind the engine compartment.

The interior measurements are actually good enough to show more than a simple consistency with exterior measurements. Indeed, the interior profiles seem to be precise enough to identify one or other of the exterior "surface classes" as being a chief contributor to the dose rate at a given interior location. For instance, both the driver's seat measurement and the rear bench measurement follow closely the trend for the "down-facing" surfaces. This stands to reason, since both locations are closest to surfaces in that category, and thus it makes sense that the trends in the latter would influence trends in the former. Conversely, the dose rates for the head position in the turret follow the "up-facing" data. This also makes sense, since this measurement point is very close to "up-facing" surfaces and far from any "down-facing" ones. The one example that does not make as much sense is the engine compartment data. These data seem to follow "down-facing" trend closely, although one might expect a larger contribution from "side-facing" surfaces to this measurement point. Perhaps interior shielding has affected this result. It should be noted that, while engine block shielding normally has an enormous impact, in this vehicle most of the mass of the engine had been removed.
